Seismic vulnerability of lifeline buildings in Himalayan province of Uttarakhand in India

Girish Chandra Joshi^b, Shailesh Ghildiyal^b, Piyooosh Rautela^{a,*}

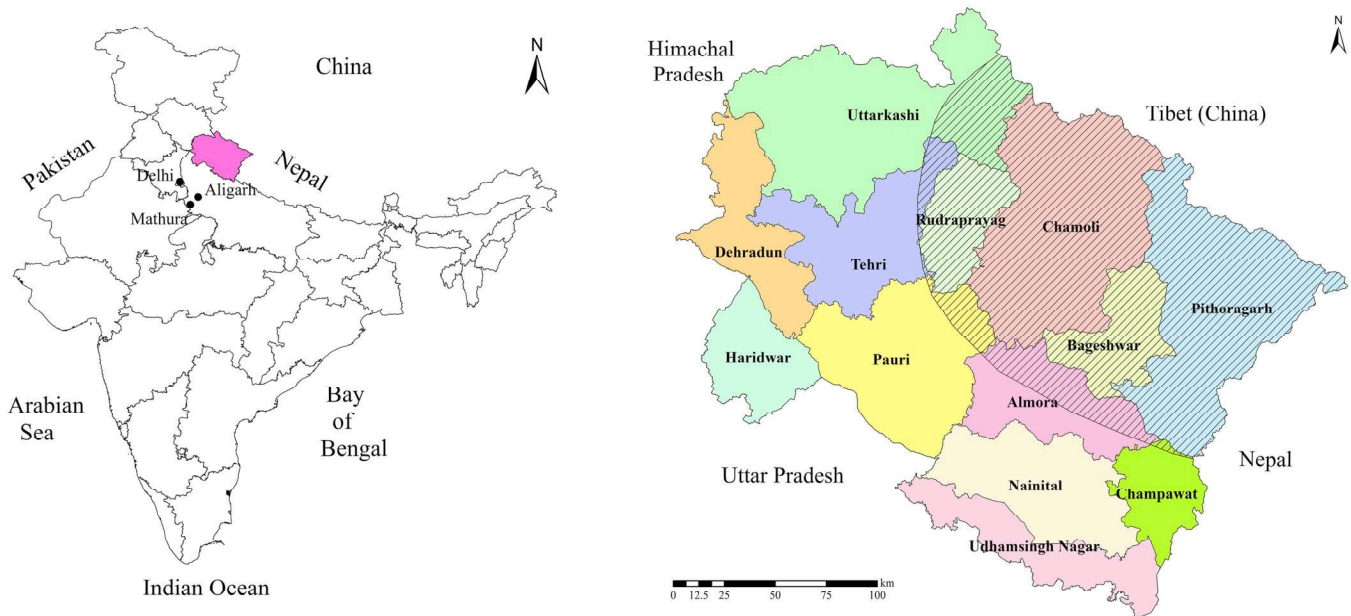
Fig. 1. Map of the province of Uttarakhand depicting district boundaries in different colours with hatched portion representing Zone V of Earthquake Zoning Map of India and unhatched portion depicting Zone IV [11].

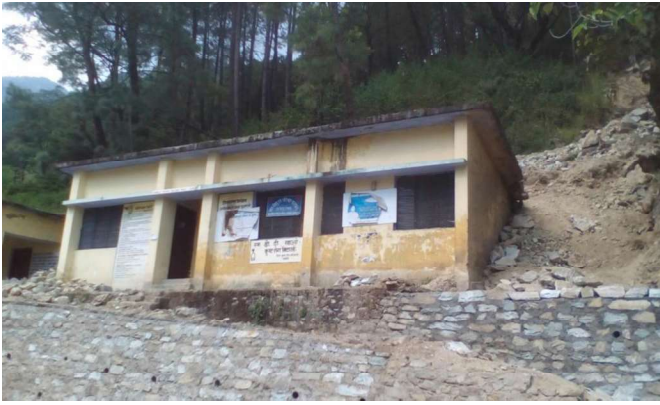
Fig. 3. Primary school at Upkendra Tangsa, Dasholi (Chamoli district) located on high sloping ground.

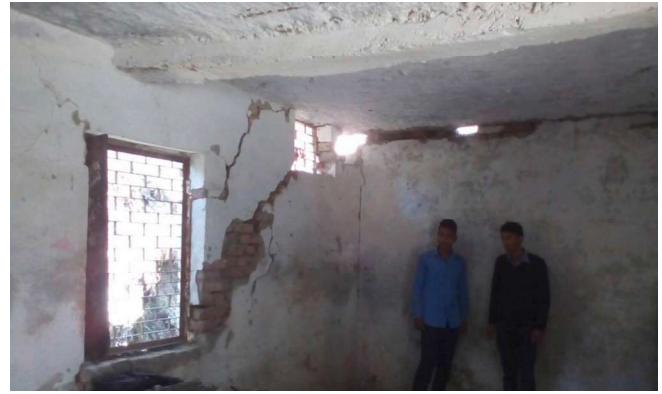
Fig. 4. Wide shear cracks in masonry wall of Government Inter College, Pitrdhar (Rudraprayag district) together with poorly constructed beam of non-uniform shape showing deflection.

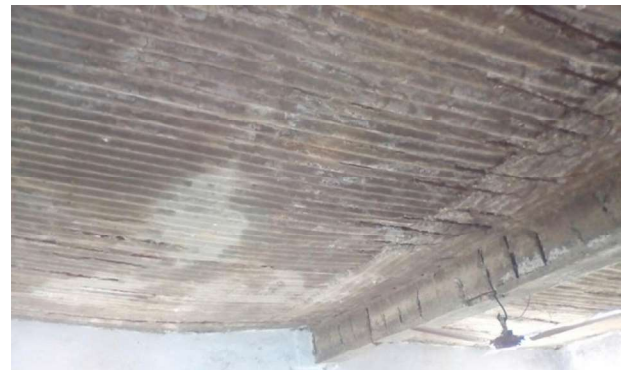
Fig. 5. Poorly constructed roof with clearly visible reinforcement at Government Primary School Mhalchora in Bageshwar district.

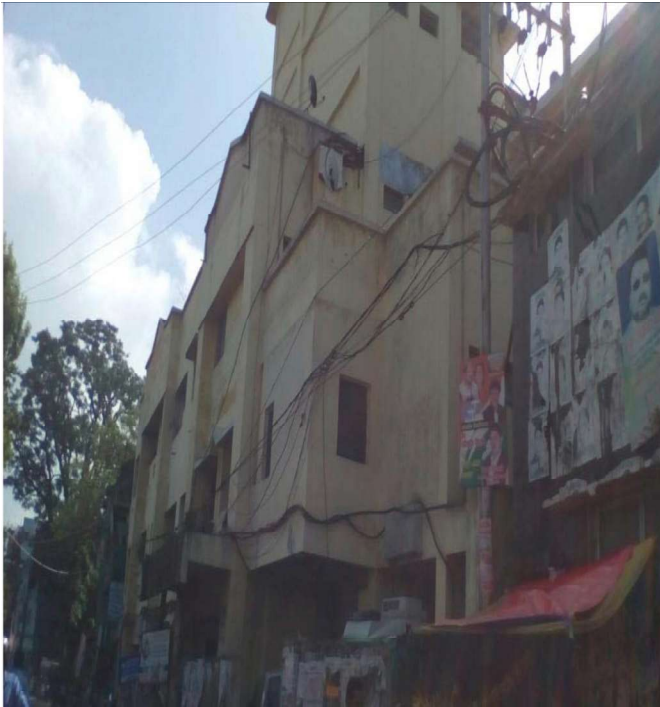
Fig. 6. Reverse-T shaped hospital at Hawalabagh in Almora district.

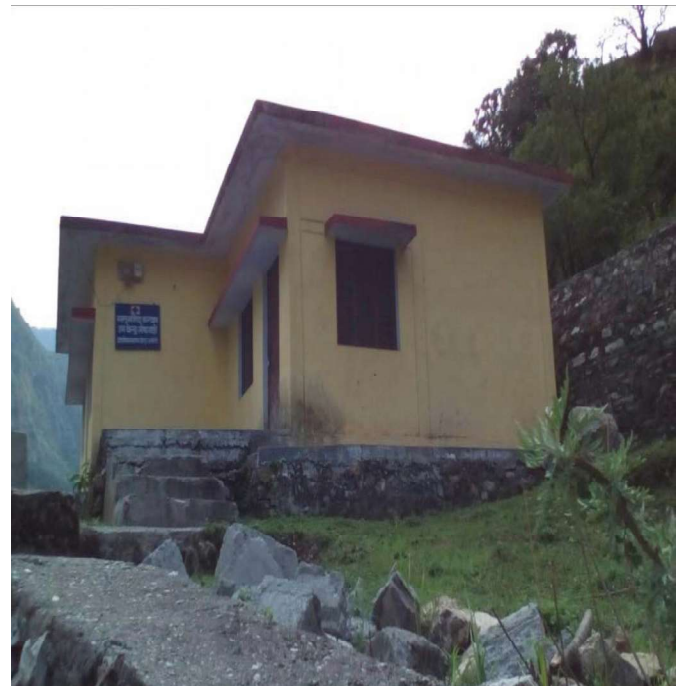
Fig. 7. Re-entrant corners in Upkendra, Gauna, Dasholi in Chamoli district.

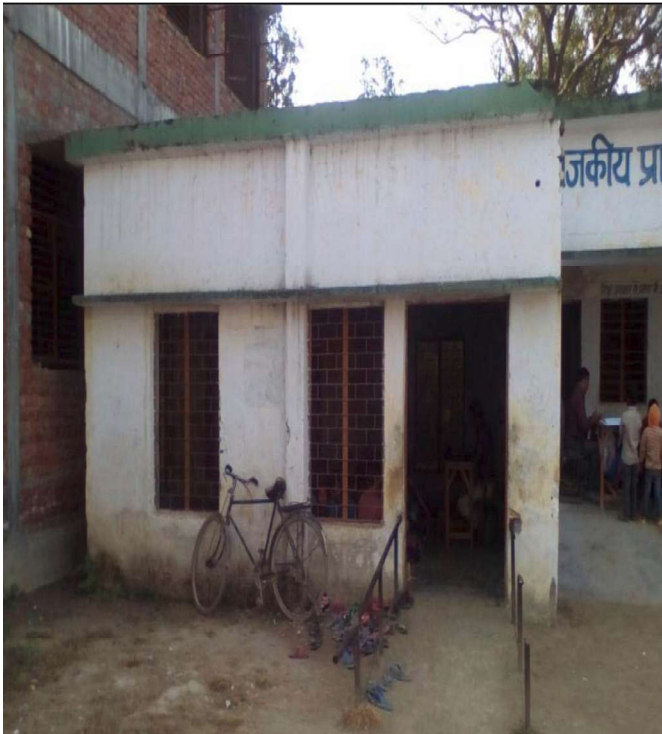
Fig. 9. Government Primary School, Bajpur in Udham Singh Nagar district is vulnerable to pounding during seismic shaking.
